CHARLESWORTH & SON LTD

Land Rover Series One Steering Wheel Removal

Horn Button / Dip Switch Assembly Rebuilding

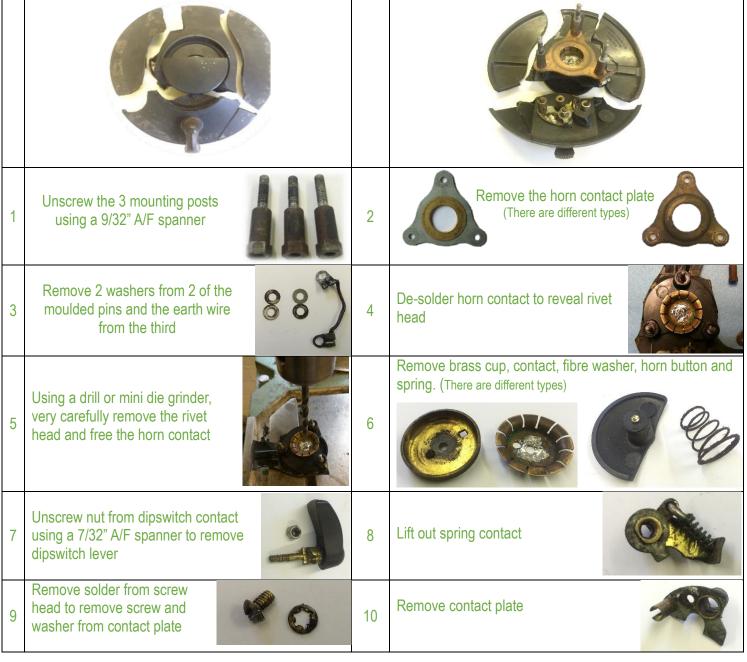
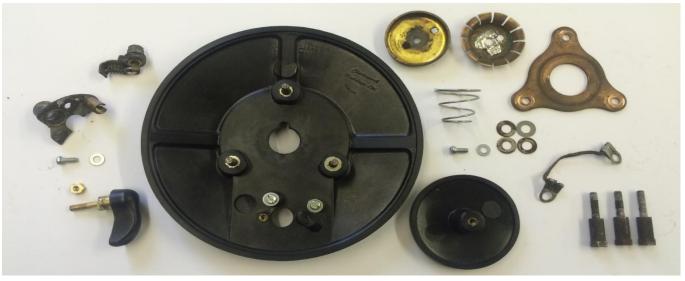
Re-assembly			
The describing				
1	Fit spring to horn button	2	Insert horn button from front of top cover and using 6BA screw (supplied), re-attach brass cup & contact. This screw will need to be removed again to fit the power feed.	
3	Replace 4 washers and earth wire	4	Replace horn contact plate	
5	Replace 3 mounting posts using 9/32" A/F spanner	6	Replace contact plate and fix into place applying threadlock to the 6BA screw (supplied)	
7	Replace spring contact assembly	8	Replace the dipswitch lever. Fix the 5BA nut with a 7/3" A/F spanner applying threadlock,	
9	Check the switches operate correctly using a multimeter.		PIG-OIP
